Refurbishment and protection of Water-Polymer Mixture Tank from further corrosion

ID: 9338

Industry: *Water / Wastewater*
Application: *TCC-Tanks and Chemical Containment Areas*
Substrate: *Carbon steel*
Products: *Belzona 5811 (Immersion Grade)*

Customer Location: *Ontario, Canada*
Application Date: *August 2023*

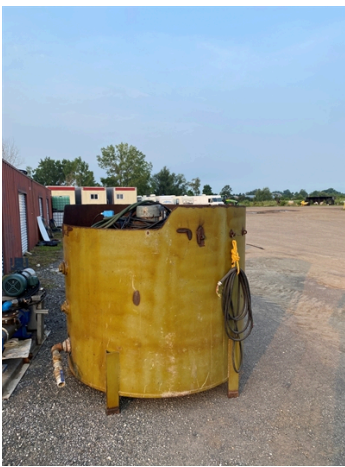
Tank was very badly corroded and required refurbishment and protection

Tank exterior prior to application.

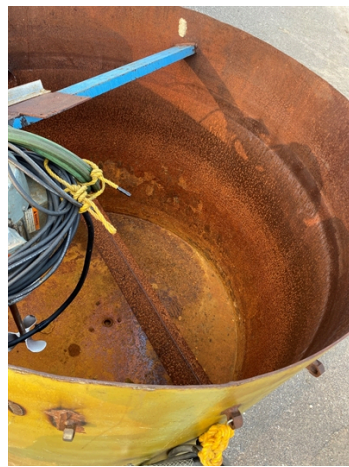
Tank interior prior to application.

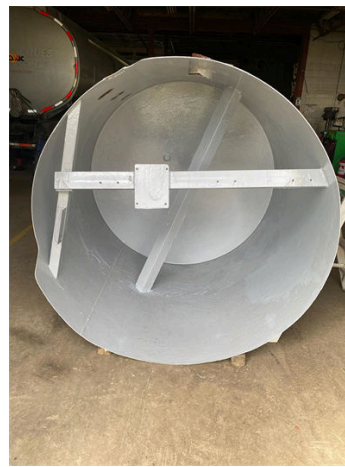
After sand blasting and application of two coats of Belzona 5811

All the elbows were grit blasted to SSPC SP10 and two coats of Belzona 5811 were applied.
