# Refurbishment and protection of Water-Polymer Mixture Tank from further corrosion

ID: 9338

Industry: *Water / Wastewater*  
Application: *TCC-Tanks and Chemical Containment Areas*  
Substrate: *Carbon steel*  
Products: *Belzona 5811 (Immersion Grade)*

Customer Location: *Ontario, Canada*  
Application Date: *August 2023*

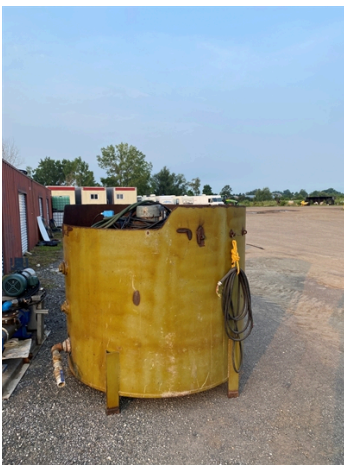
*Tank was very badly corroded and required refurbishment and protection*

Tank exterior prior to application.

All the elbows were grit blasted to SSPC SP10 and two coats of Belzona 5811 were applied.

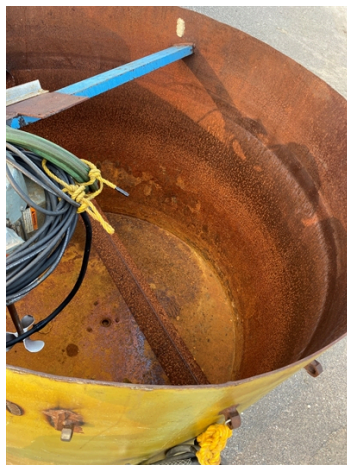
Tank interior prior to application.

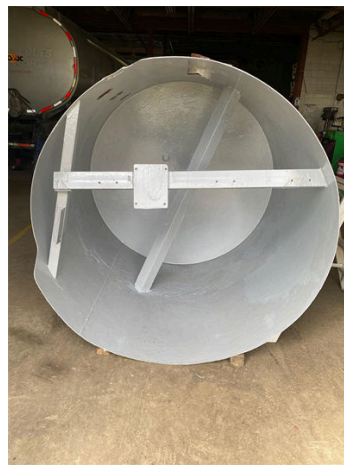
After sand blasting and application of two coats of Belzona 5811
