# Chemically damaged floor rebuilt and protected with Belzona

Customer Location: Sarnia, Ontario

Application: FPA-Floor Problem Areas

Application Date: September 2019

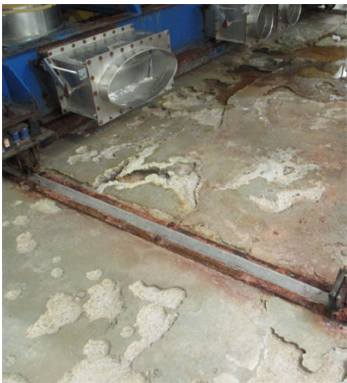
Manufacturing plant that processes Bio-based succinic acid was having issues with their floors. Dry process material of Bio-based succinic acid was being spill onto the concrete floor and during floor washing operations, water activated the acid and this one started to attack the concrete.

Floor damage caused by Succinic Acid

The damaged concrete was washed and decontaminated. Missing concrete areas were refurbished and smooth out. 2coats of Belzona 4311 (Magma CR1) were applied to prevent future deterioration of the concrete via chemical attack.

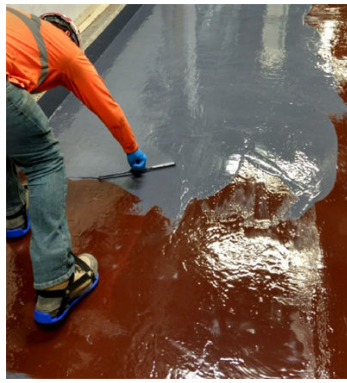
Applying second coat of Belzona 4311

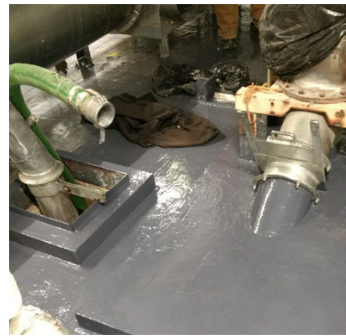
Second coat of Belzona 4311 around floor step up's and piping equipment through floor.

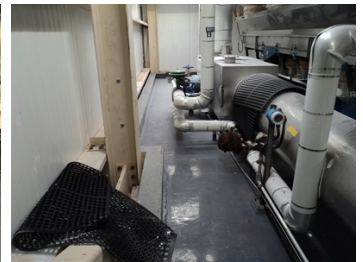
Finished floor coating Belzona 4311

The customer had interest in performing further tests, so we provided small brick samples coated with Belzona 4311 (Magma CR1). The coated samples were immersed in Succinic acid for 1 month. The coating did not exhibit any sign of deterioration. the customer was pleased with the performance of the coating and decided to proceed. The coating was inspected in late 2023 (4 years later) and

was still protecting the floor.
