# Chemically damaged floor rebuilt and protected with Belzona

Customer Location: Sarnia, Ontario

Application: FPA-Floor Problem Areas

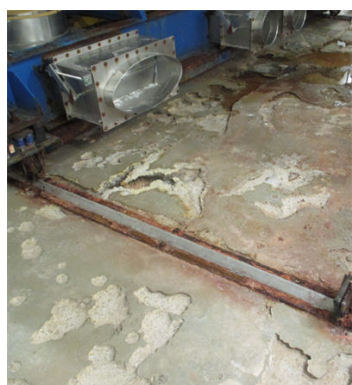
Manufacturing plant that processes Bio-based succinic acid was having issues with their floors. Dry process material of Bio-based succinic acid was being spill onto the concrete floor and during floor washing operations, water activated the acid and this one started to attack the concrete.

Floor damage caused by Succinic Acid

The damaged concrete was washed and decontaminated. Missing concrete areas were refurbished and smooth out. 2coats of Belzona 4311 (Magma CR1) were applied to prevent future deterioration of the concrete via chemical attack.

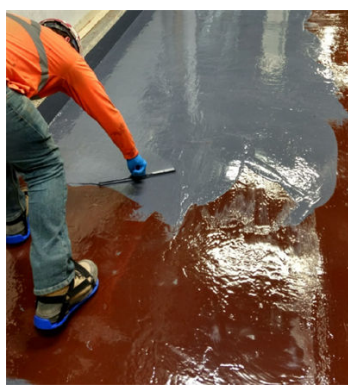
Applying second coat of Belzona 4311

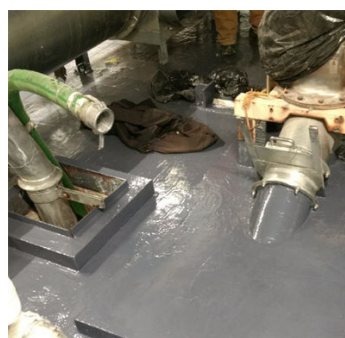
Second coat of Belzona 4311 around floor step up's and piping equipment through floor.

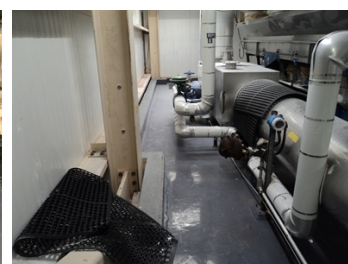
Finished floor coating Belzona 4311

The customer had interest in performing further tests, so we provided small brick samples coated with Belzona 4311 (Magma CR1). The coated samples were immersed in Succinic acid for 1 month. The coating did not exhibit any sign of deterioration. the customer was pleased with the performance of the coating and decided to proceed. The coating was inspected in late 2023 (4 years later) and

was still protecting the floor.
