# Chemically damaged floor rebuilt and protected with Belzona

Application: FPA-Floor Problem Areas

Substrate: Concrete

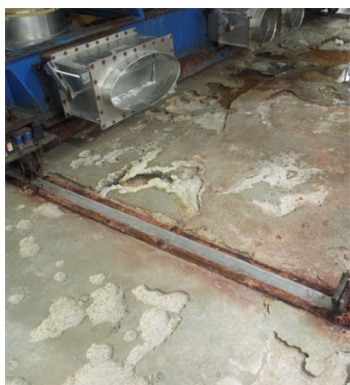
Manufacturing plant that processes Bio-based succinic acid was having issues with their floors. Dry process material of Bio-based succinic acid was being spill onto the concrete floor and during floor washing operations, water activated the acid and this one started to attack the concrete.

Floor damage caused by Succinic Acid

The damaged concrete was washed and decontaminated. Missing concrete areas were refurbished and smooth out. 2coats of Belzona 4311 (Magma CR1) were applied to prevent future deterioration of the concrete via chemical attack.

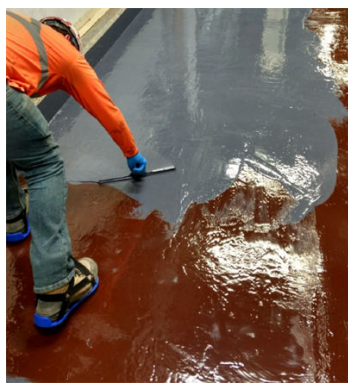
Applying second coat of Belzona 4311

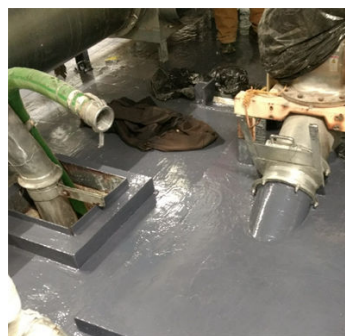
Second coat of Belzona 4311 around floor step up's and piping equipment through floor.

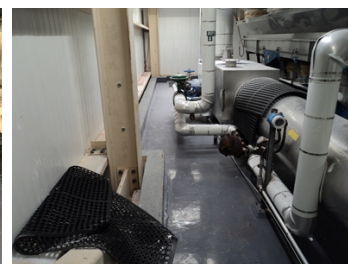
Finished floor coating Belzona 4311

The customer had interest in performing further tests, so we provided small brick samples coated with Belzona 4311 (Magma CR1). The coated samples were immersed in Succinic acid for 1 month. The coating did not exhibit any sign of deterioration. the customer was pleased with the performance of the coating and decided to proceed. The coating was inspected in late 2023 (4 years later) and

was still protecting the floor.
