# BELZONA SEALS WAREHOUSE FLOOR

Application: FPA-Floor Problem Areas

Substrate: Concrete floor with block walls

Customer Location: Chemical Producer, Pennsylvania USA

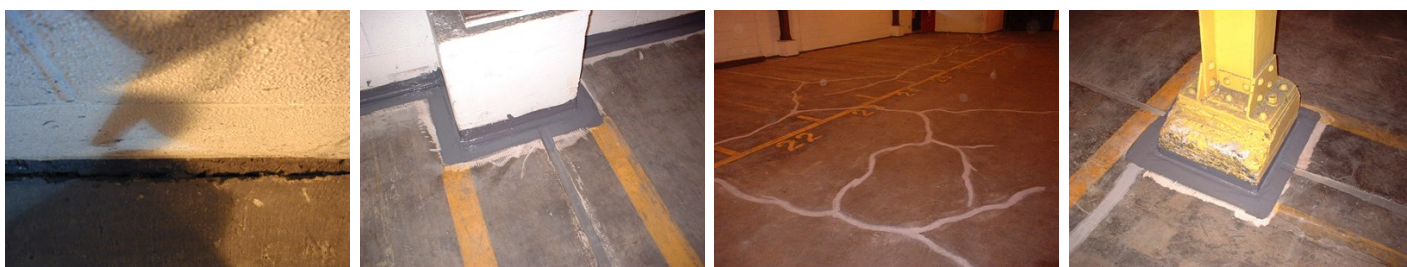
Chemical spills however quickly cleaned up could contaminate ground-water. Facility near two major rivers. Floor had many cracks and gaps around wall to floor detail.

- \* Floor to wall joint before sealing ,
- \* Sealing warehouse floor-expansion joints ,
- \* Sealing joint around perimeter ,
- \* Repaired/sealed cracks with Belzona® 4131 ,

Application was carried out following Belzona Know-How System Leaflets FPA-6 and TCC-15. Cracks were chased out before being filled and sealed.
