BELZONA SEALS WAREHOUSE FLOOR

ID: 934

Application: FPA-Floor Problem Areas

Customer Location: Chemical Producer, Pennsylvania USA

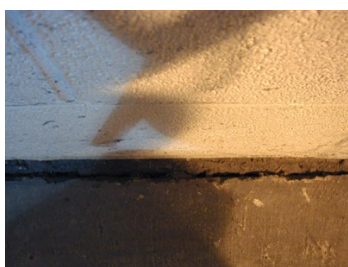
Chemical spills however quickly cleaned up could contaminate ground-water. Facility near two major rivers. Floor had many cracks and gaps around wall to floor detail.

- * Floor to wall joint before sealing ,
- * Sealing warehouse floor-expansion joints ,
- * Sealing joint around perimeter ,
- * Repaired/sealed cracks with Belzona® 4131 ,

Application was carried out following Belzona Know-How System Leaflets FPA-6 and TCC-15. Cracks were chased out before being filled and sealed.
