Repair of wear and through wall defect on Volute of Pumps and Protection of Pumps from further corrosion

ID: 9340

Application: CEP-Centrifugal Pumps

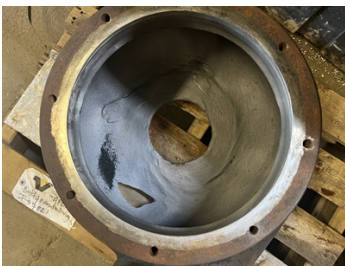
Through wall defect and wear in pump caused by sewage and particles in wastewater was to be repaired and lined with intention of getting more lives out of the pumps.

First pump with through wall after grit blasting.

Pumps were grit blasted to SSPC SP10. First pump was rebuilt, hole repaired using a metal plate and entire interior covered with Belzona 1111. Wear on inside of pump 2 also rebuilt using Belzona 1111. Afterwards, two coats of Belzona 1321 were applied to both pumps.

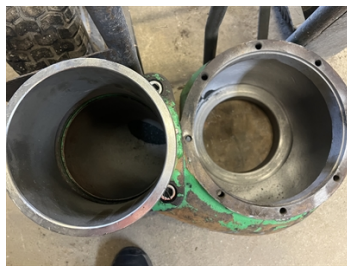
Second pump with wear after blasting

Pumps were badly worn due to particles in sewage and wastewater. Therefore, customer needed to not only repair but protect pumps from future occurrence.

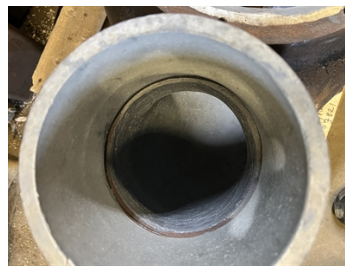
After rebuilding wear on pump with Belzona 1111.

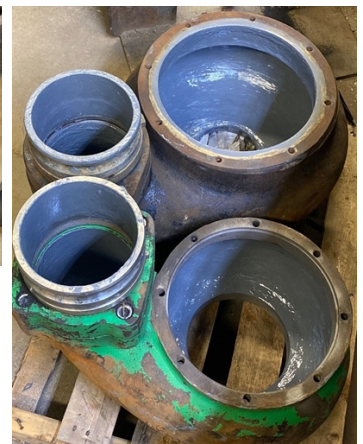
First pump after plate bonding with Belzona 1111 and both pumps lined with Belzona 1321.
