# Wind turbine blades LEP protected with Belzona 5721

ID: 9341

Industry: Power

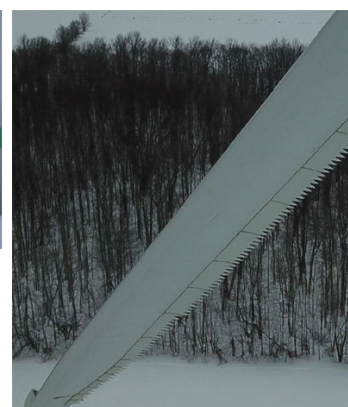
Repairs and Sanding complete

Ready for degreaser and cleaner

Belzona 5721 application

Inspection after 7 months of back in service

Before the application of Belzona 5721, the surface of the LEP was cleaned and sanded. Defects and areas that needed rebuild were repaired. Once a clean and even surface was achieved, Belzona 2911 (Elastomer QD Conditioner) was applied to condition the surface and allowed to become touch dry. Then, one coat of Belzona 5721 was applied to the thickness of 20 mils. The product was allowed to cure before putting the turbine back in service.

The product was inspected via drone after 7 months in service, and the product appeared to be intact with no signs of wear, chalking or peeling.
