Weakened pipe reinforced with plate bonding and SW

ID: 9342

Application: VPF-Valves, Pipes and Fittings

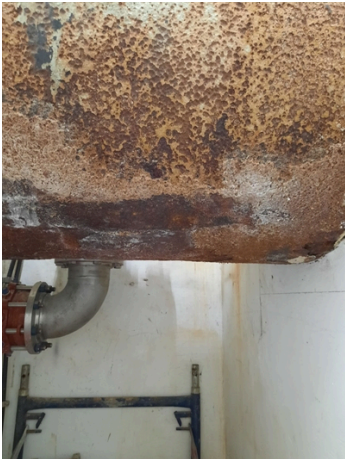
A pipe in a wastewater plant needed had suffered from external corrosion and metal loss over the years.

Defective pipe

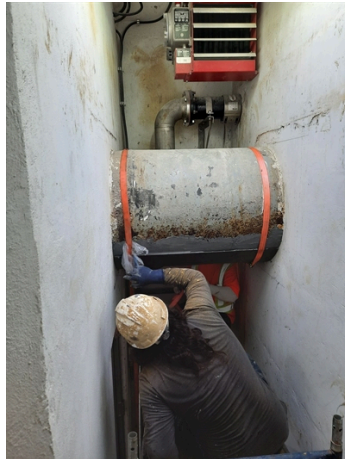
Plate bonding over the most critical area

The pipe was so deteriorated that they were concerned that abrasive blasting the bottom of the pipe will puncture the pipe and create through wall defects. It was decided to do a plate bonding with a surface tolerant product as an initial reinforcement before further reinforcing with SWII.

First, the pipe was prepared as best as possible. Then we did a plate bonding repair with Belzona 1161 to protect the bottom section of the pipe. After, we grit blasted the rest of the pipe and reinforced the rest of the pipe with Belzona Superwrap II.

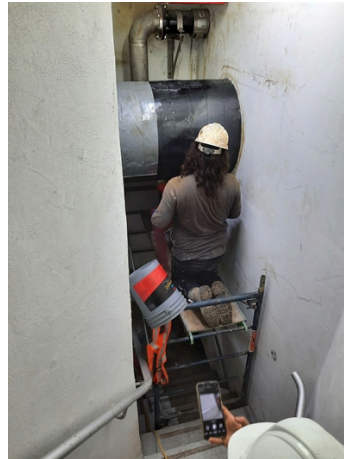
1st layer of Belzona SWII
