Reviving Gray and Black Tanks Inside a Marine Vessel with Belzona Solutions

ID: 9343

Industry: Marine
Application: TCC-Tanks and Chemical Containment Areas

Customer Location: Ontario, Canada
Application Date: September 2023

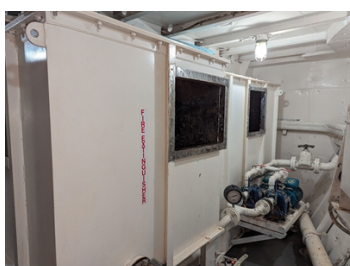
The gray and black tanks inside the marine vessel were suffering from coating failure and corrosion issues. The main flange also required repair from wear.

Tanks before surface preparation.

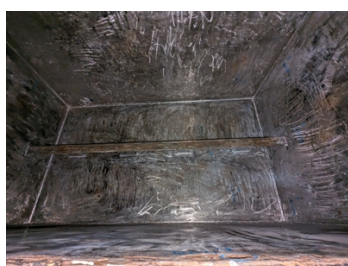
After surface preparation.

After solvent cleaning, and then with the use of a power tool, tank internal surfaces were prepared to SP11. Flanges were also rebuilt using Belzona 1111. Two coats of Belzona 5811 were then applied.

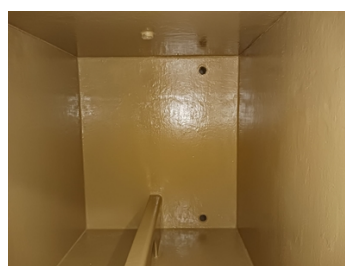
Gray Tank After application of two coats of Belzona 5811.

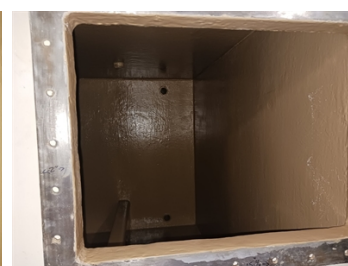
Black Tank After application of two coats of Belzona 5811.
