Reviving Gray and Black Tanks Inside a Marine Vessel with Belzona Solutions

Application: TCC-Tanks and Chemical Containment Areas

Substrate: Cast Iron

Products: Belzona 1111 (Super Metal), Belzona 5811 (Immersion Grade)

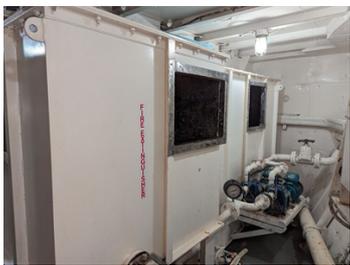
The gray and black tanks inside the marine vessel were suffering from coating failure and corrosion issues. The main flange also required repair from wear.

Tanks before surface preparation.

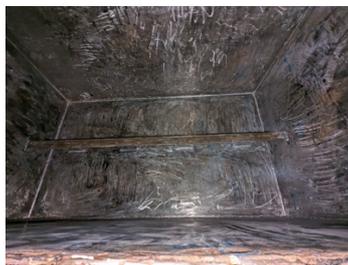
After surface preparation.

After solvent cleaning, and then with the use of a power tool, tank internal surfaces were prepared to SP11. Flanges were also rebuilt using Belzona 1111. Two coats of Belzona 5811 were then applied.

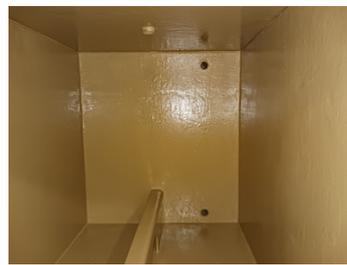
Gray Tank After application of two coats of Belzona 5811.

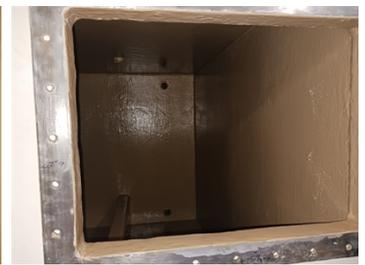
Black Tank After application of two coats of Belzona 5811.
