# Stemming and Sealing High Voltage Transformer Oil Leak

ID: 9344

Customer Location: Ontario, Canada

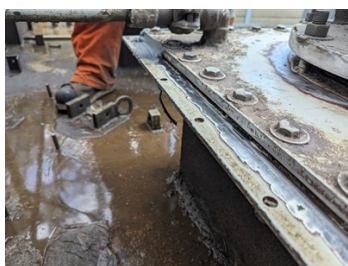
Transformer after surface preparation.

Surface was wiped clean using solvent / degreaser and then prepared according to SP11 standards. Surface was wiped clean and leak sealed using Belzona 1161 and 9341. Afterwards, two coats of Belzona 5831 was applied.

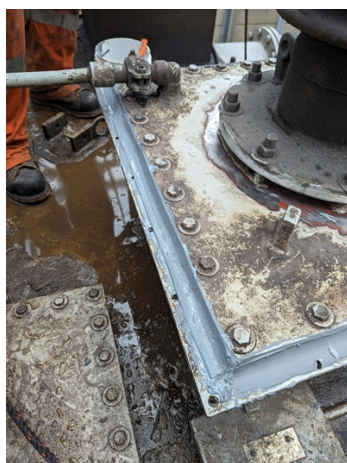
Leaks stemmed and sealed with Belzona 1161

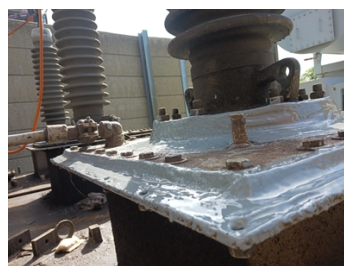
Coating to avoid permeation.
