Stemming and Sealing High Voltage Transformer Oil Leak

ID: 9344

Application: MPT-Mechanical Power Transmission

Products: Belzona 1161 (Super UW-Metal), Belzona 5831 (ST-Barrier), Accessories

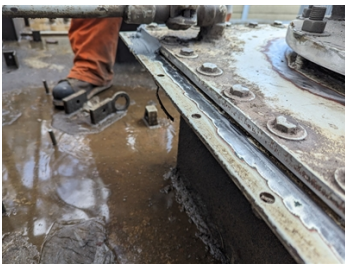
Transformer after surface preparation.

Surface was wiped clean using solvent / degreaser and then prepared according to SP11 standards. Surface was wiped clean and leak sealed using Belzona 1161 and 9341. Afterwards, two coats of Belzona 5831 was applied.

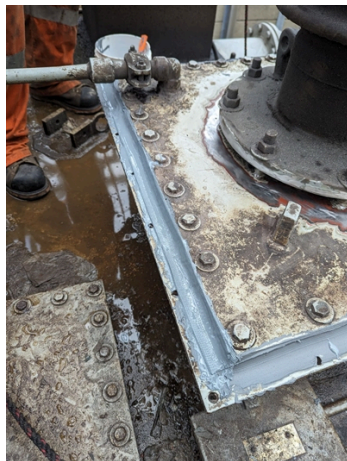
Leaks stemmed and sealed with Belzona 1161

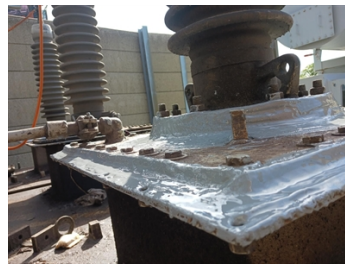
Coating to avoid permeation.
