Coated Secondary Containment Areas

ID: 9347

Industry: Water / Wastewater
Application: FPA-Floor Problem Areas
Substrate: Concrete
Products: Belzona 4311 (Magma CR1), Belzona 4911 (Magma TX Conditioner), Belzona 5811 (Immersion Grade), Belzona 9111 (Cleaner Degreaser)

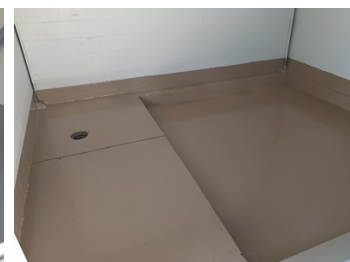
Application Belzona 5811 Completed
