Leaking Porous Weld Repair

ID: 9352

Industry: Water / Wastewater

Application: VPF-Valves, Pipes and Fittings

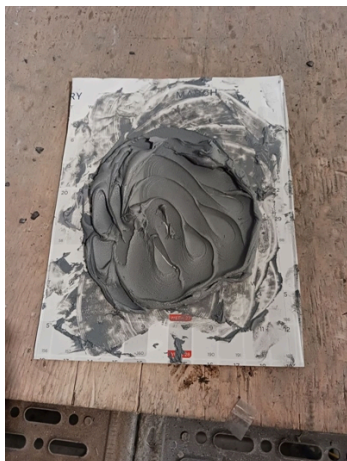
Belzona 1111 mixed

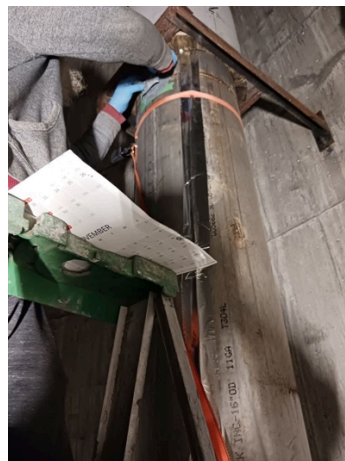
Application of Belzona 1111

Preparation was completed in-way of using a grinder with a 80 grit sanding pad, than cleaned with Belzona 9111. Next the Belzona 1111 repair composite was mixed and applied well into the preferred area. Using a piece of Belzona 9341 Reinforcing cloth was wetted out and applied over the repair area with a further layer of Belzona 1111 until the cloth was covered.

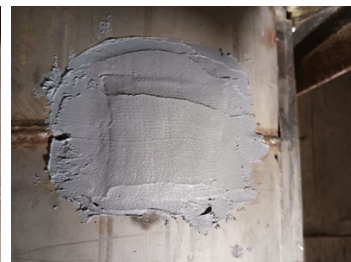
Application completed
