Leaking Porous Weld Repair

ID: 9352

Industry: Water / Wastewater

Application: VPF-Valves, Pipes and Fittings

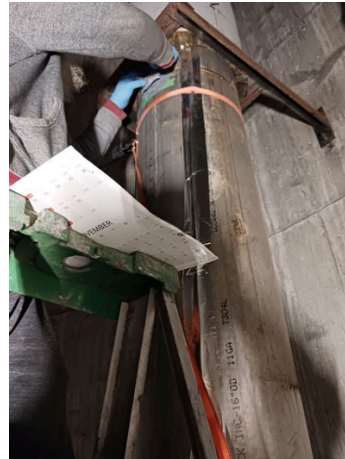
Belzona 1111 mixed

Preparation was completed in-way of using a grinder with a 80 grit sanding pad, than cleaned with Belzona 9111. Next the Belzona 1111 repair composite was mixed and applied well into the preferred area. Using a piece of Belzona 9341 Reinforcing cloth was wetted out and applied over the repair area with a further layer of Belzona 1111 until the cloth was covered.

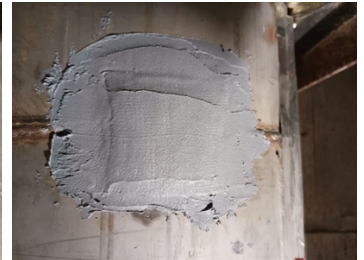
Application of Belzona 1111
