Diffuser ring resurface and coated with Belzona

ID: 9353

Application: CEP-Centrifugal Pumps

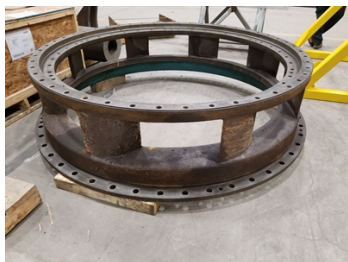
Diffuser ring was corroded and certain areas were worn out and needed to be resurfaced.

Initial state of the ring.

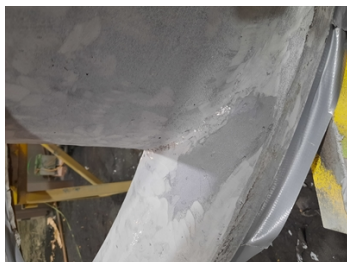
Resurfacing with Belzona 1111. 1st coat of Belzona 1341.

The inner surface of the ring was resurfaced with Belzona 1111 and then it was followed by two coats of Belzona 1341.

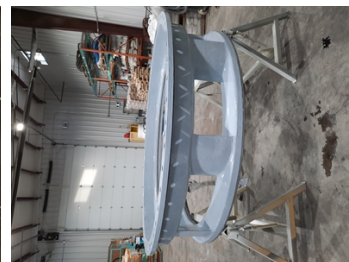
After application of 2nd coat.
