# Repairing the shaft of a vintage air handler unit, aged over 50 years

ID: 9356

Application: FBC-Fans, Blowers and Compressors

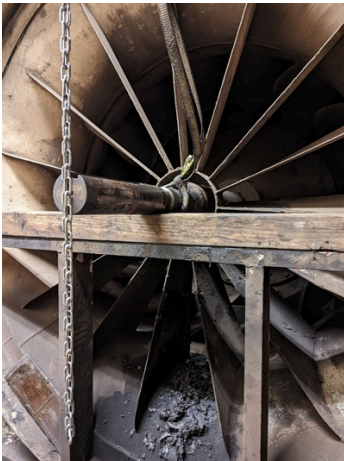
Air handler Unit

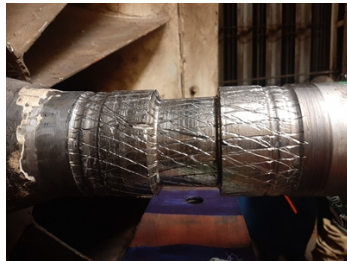
Shaft after surface preparation

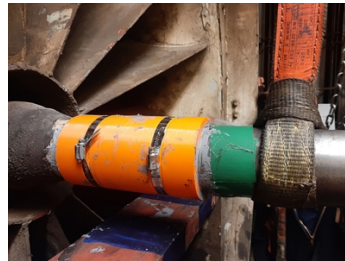
In-situ repair with 3D mold

As it was very challenging to remove the shaft for the repair, Belzona has offered in-situ repair with the use of 3D mold. By doing this, the client has shortened the air handling unit's maintenance time.

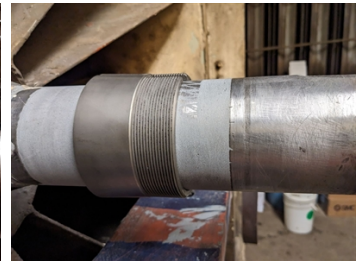
Successful repair
