Belzona Rebuilds and Resurfaces Ships Tail Shaft

ID: 9357

Industry: *Marine*
Application: *SOS-Ships and Offshore Structures*

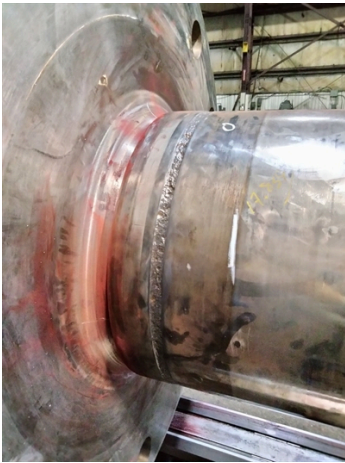
Shaft preparation completed for rebuilding

Preparation was carried out using hand tooling, cleaned using Belzona 9111 as per the Instruction For Use (IFU) the products, Belzona 1111 was used for rebuilding and Belzona 1331 was used for a protective coating for it offers erosion and corrosion resistance and can be applied with a heavy single coat without sagging.

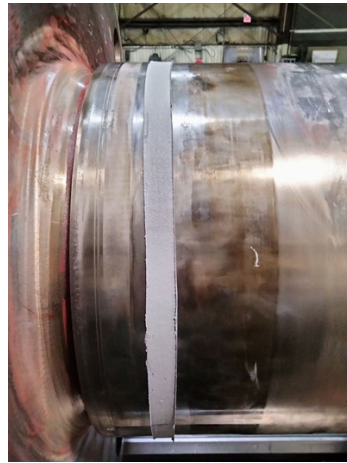
Belzona 1111 application finished and ready for machining

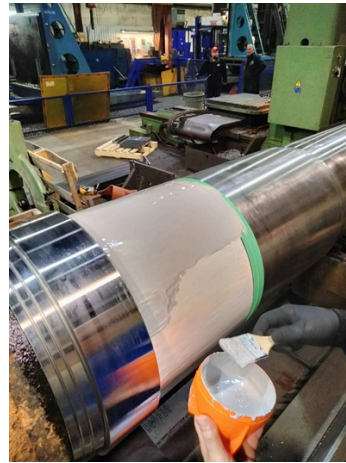
Application of Belzona 1331 second coat

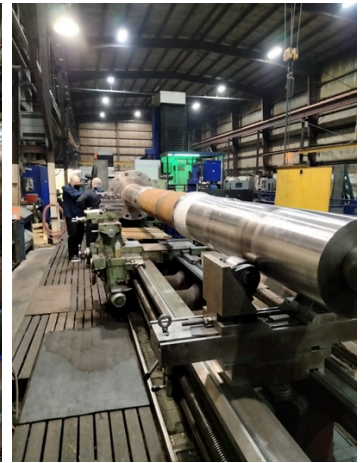
Shaft repair areas waiting on cure times so the machine shop can machine to the correct measurements.
