Cold bonding to repair leaky cooling tower

Industry: Heating, Ventilation & Air Conditioning
Application: HEX-Heat Exchangers
Substrate: Carbon steel
Products: Belzona 1111 (Super Metal)

Customer Location: Kitchener
Application Date: April 2019

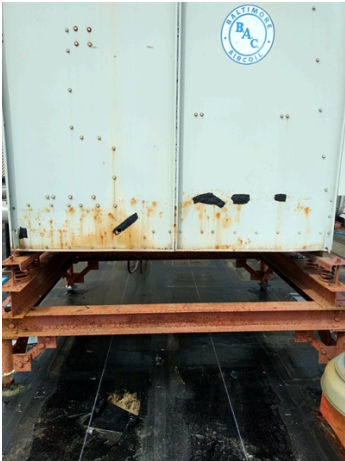
Customer was having problems with their cooling tower. The equipment was experiencing corrosion and in some areas they even had through wall defects.

Damaged cooling tower

The customer wanted to seal the holes in the equipment to prevent further deterioration. They did not want to weld as they knew that welding would require specialized equipment, hot work and post-welding treatment to revert metallurgical changes caused by welding. We showed the advantages of our Belzona cold bonding solution and the customer decided to proceed with it.

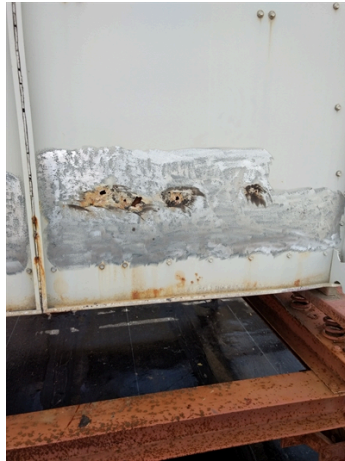
Surface preparation with a grinder over the affected area

Patch plates were pre-designed to fit the damaged area. The surface of the weakened substrate and underside of the plate were cleaned and abraded to create a mechanical profile. Belzona 1111 was mixed and applied over the damaged area and on the underside of patch plate, making sure the material was wetting out the profile as much as possible. The metal plate was then forced on to the weakened substrate. Excess material exuding from the edges was removed and chamfered around the perimeter of the plate.

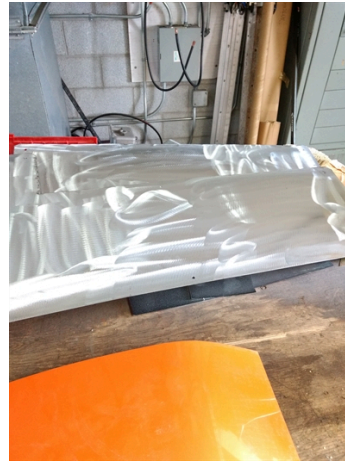
Surface preparation on the underside of the plate to be bonded

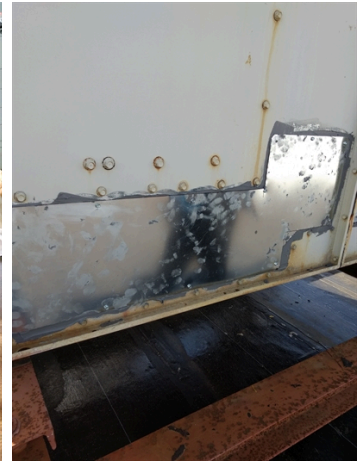
Complete repair

The repair was completed in a few hours with minimal disruption to the facility operations. The cold bonding solution is a robust repair and the customer can expect a long term repair out if this solution.
