Belzona SuperWrap II restores pipe integrity

ID: 9360

Industry: Chemical & Petrochemical
Application: VPF-Valves, Pipes and Fittings
Substrate: Carbon steel
Products: Belzona 1212, Belzona 1981 (SuperWrap II)

Customer Location: United Kingdom
Application Date: February 2024

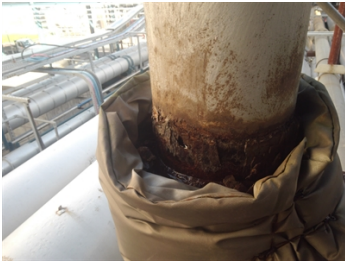
A section of cooling water pipework was corroded through wall. A repair was required to prevent any leaks occurring and to restore strength to the pipework.

Corroded pipe section

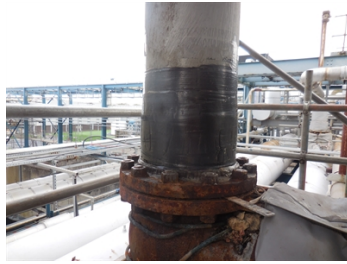
Completed repair with Belzona 1981 SuperWrap 2 installed

The area was cleaned & roughened using angle grinders. Belzona 1212 was then applied to fill any large pits & to fair the surface. Four overlapping wraps of Belzona SuperWrap II were then applied & consolidated with Belzona 9382

This repair was completed in one day with minimal disruption to the surrounding plant operations. The high strength of the system will ensure pipe integrity even if corrosion continues to occur on the underlying metal.
