Submersible Multi Stage Pump Repairs and Coatings

ID: 9361

Application: CEP-Centrifugal Pumps

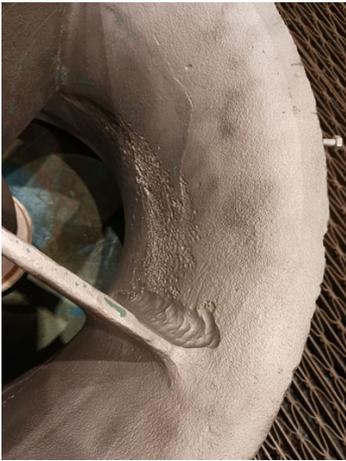
Preparation in progress for rebuilding of pumps bowls and suction bell as per the IFU

pumps were dismantled by the site's maintenance team and all parts of the equipment received grit blasting and than cleaned using Belzona 9111. All areas requiring rebuilding was completed using Belzona 1121 due to the extended working life and the overcoat window time. Belzona 1321 was used for the internal coating and Belzona 4311 was used on the externals of the equipment.

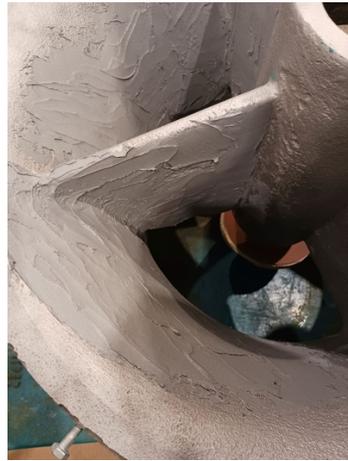
Repaired areas of pump bowls using Belzona 1121

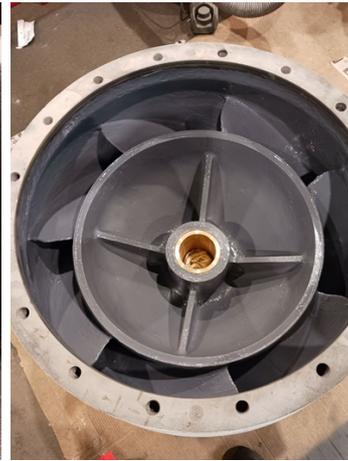
First coat of Belzona 1321

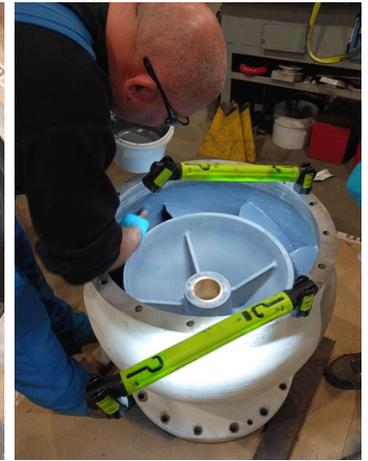
Second coat of Belzona 1321
