Submersible Multi Stage Pump Repairs and Coatings

ID: 9361

Industry: Oil & Gas
Application: CEP-Centrifugal Pumps
Substrate: Carbon steel
Products: Belzona 1121 (Super XL-Metal), Belzona 1321 (Ceramic S-Metal), Belzona 4311 (Magma CR1), Belzona 9111 (Cleaner Degreaser)

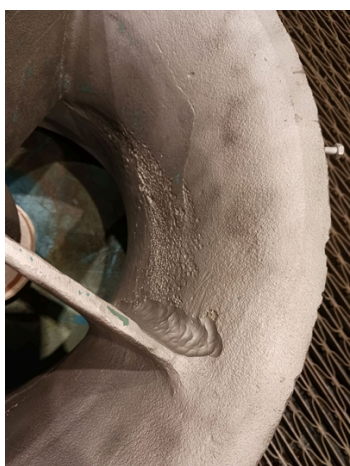
Preparation in progress for rebuilding of pumps bowls and suction bell as per the IFU

pumps were dismantled by the site's maintenance team and all parts of the equipment received grit blasting and than cleaned using Belzona 9111. All areas requiring rebuilding was completed using Belzona 1121 due to the extended working life and the overcoat window time. Belzona 1321 was used for the internal coating and Belzona 4311 was used on the externals of the equipment.

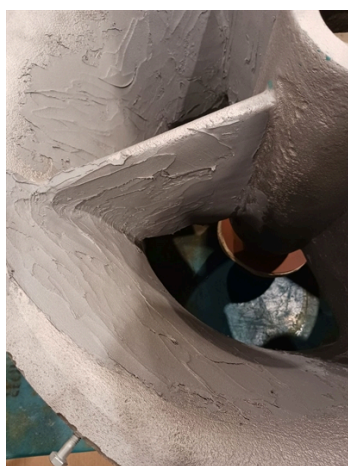
Repaired areas of pump bowls using Belzona 1121

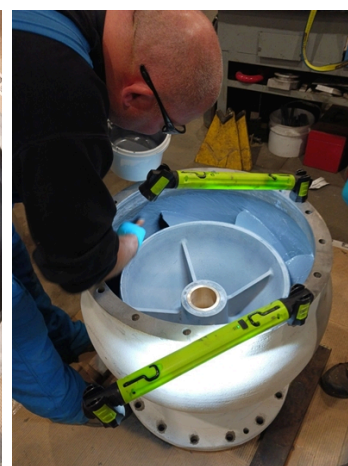
Second coat of Belzona 1321
