# Submersible Multi Stage Pump Repairs and Coatings

ID: 9361

Application: CEP-Centrifugal Pumps

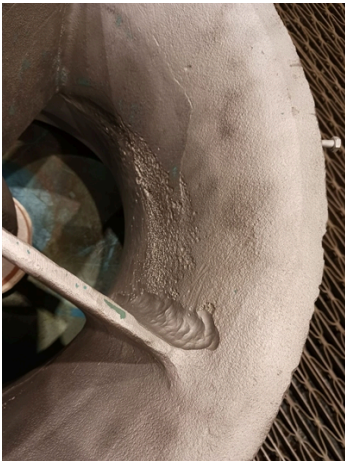
Preparation in progress for rebuilding of pumps bowls and suction bell as per the IFU

pumps were dismantled by the site's maintenance team and all parts of the equipment received grit blasting and than cleaned using Belzona 9111. All areas requiring rebuilding was completed using Belzona 1121 due to the extended working life and the overcoat window time. Belzona 1321 was used for the internal coating and Belzona 4311 was used on the externals of the equipment.

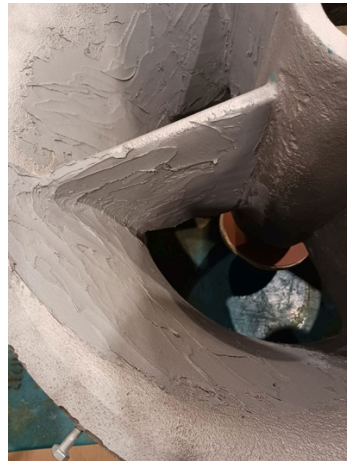
Repaired areas of pump bowls using Belzona 1121
