# Belzona Saves Hospital AHU Condensate Pan

ID: 9362

**Application:** TCC-Tanks and Chemical Containment Areas

**Application Date:** March 2022

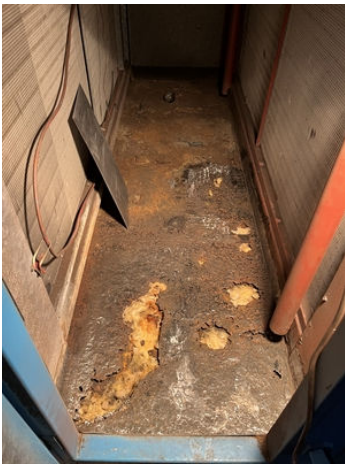
Water condensing on the cooling coils would trickle down to the collection pan. Over the years the pan corroded to the point where large holes developed. Water would leak out through the bottom of the AHU and then down to the hospital operating room below causing disruptions and potential health/mould problems above the ceiling tiles.

Surface preparation to reveal holes in pan and ready for cold plate bonding.

The entire pan was power tool cleaned to SSPC-SP11 bare metal cleanliness using grinders and wire wheels. The pan was then degreased with MEK. Several 6mm thick steel plates were measured and cut, then bonded into place using procedure TCC-1 with Belzona 1161. Once Belzona 1161 cured the entire pan was coated with 2 coats of Belzona 5831LT for best adhesion to a power tool cleaned surface, and anticipated humid environment.

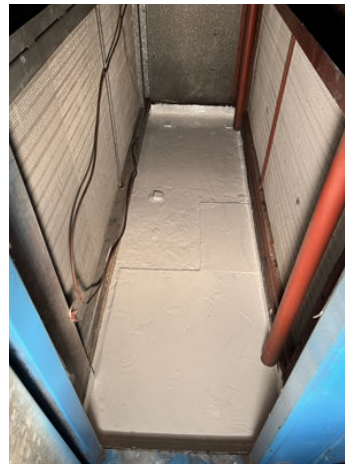
First coat of Belzona 5831LT White applied.

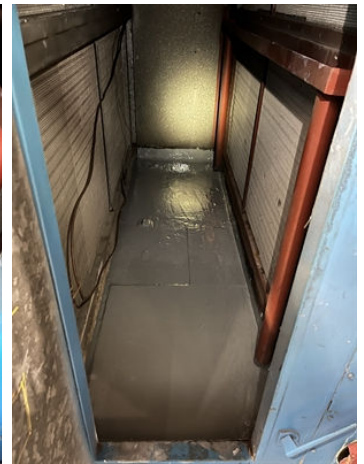
Second coat of Belzona 5831LT Grey applied.

Follow-up inspection two years later revealed the Belzona application to be in excellent condition.
