Belzona Saves Hospital AHU Condensate Pan

ID: 9362

Industry: Heating, Ventilation & Air Conditioning
Application: TCC-Tanks and Chemical Containment Areas
Substrate: Carbon steel
Products: Belzona 1161 (Super UW-Metal), Belzona 5831LT

Customer Location: Nova Scotia, Canada
Application Date: March 2022

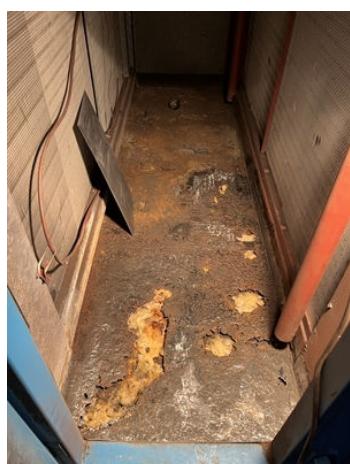
Surface preparation to reveal holes in pan and ready for cold plate bonding.

The entire pan was power tool cleaned to SSPC-SP11 bare metal cleanliness using grinders and wire wheels. The pan was then degreased with MEK. Several 6mm thick steel plates were measured and cut, then bonded into place using procedure TCC-1 with Belzona 1161. Once Belzona 1161 cured the entire pan was coated with 2 coats of Belzona 5831LT for best adhesion to a power tool cleaned surface, and anticipated humid environment.
