# Plate bond to repair and protect a chute that has powder lime blown through it

ID: 9366

Industry:	General Industry	Customer Location:	Baton Rouge, LA
Application:	SHM-Solids Handling Machinery	Application Date:	April 2024
Substrate:	Carbon steel		
Products:	Belzona 1212,Belzona 1812 (Ceramic Carbide FP)

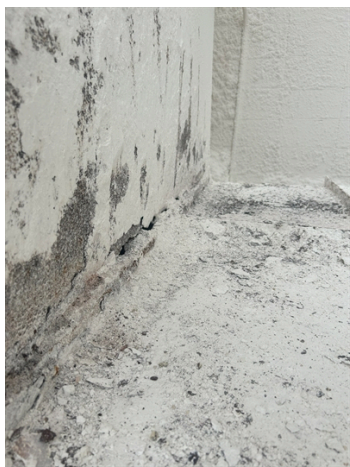
The chute which carries powder lime had a hole in it they needed to repair in place while adding abrasion protection with Belzona 1812

Area before being cleaned and prepared for work.

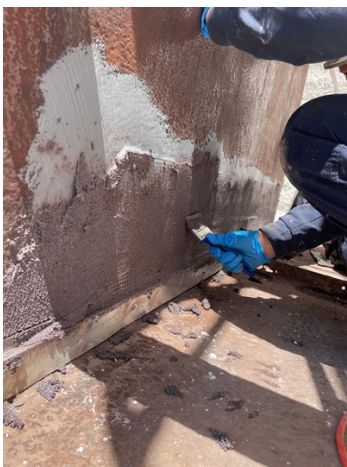
Area being prepared for application of Belzona 1212 and plate bond with Belzona 1812.

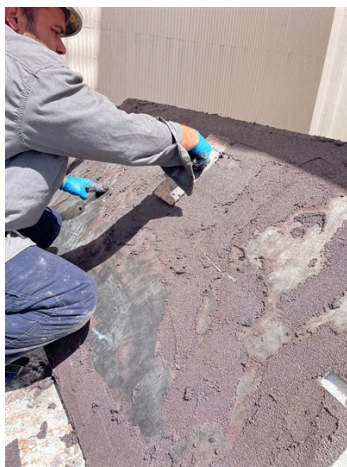
Belzona 1812 being applied to prepared plate to get ready to bond it to the chute.

Belzona application tools and short bristled brushes were used for the hand application of Belzona 1812 and Belzona 1212.

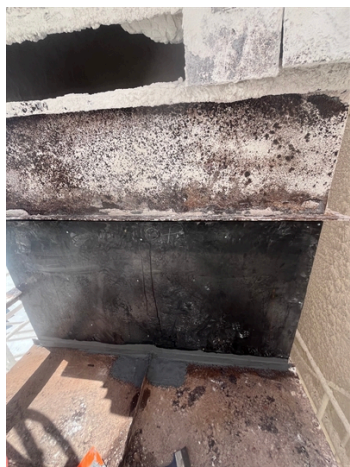
Job complete. Belzona 1212 and reinforcement cloth used to repair holes then a plate was boned with Belzona 1812 for abrasion protection.

The Belzona repair was the most cost effective due to being unable to weld in this area. They also wanted to add abrasion protection for the future, so a plate bond with Belzona 1812 was perfect for this.
