BELZONA REFURBISHES LABORATORY WORKTOPS

ID: 937

Industry: Water / Wastewater
Application: WPA-Wall Problem Areas
Substrate: unknown
Products: Belzona® 5811 (Immersion Grade)

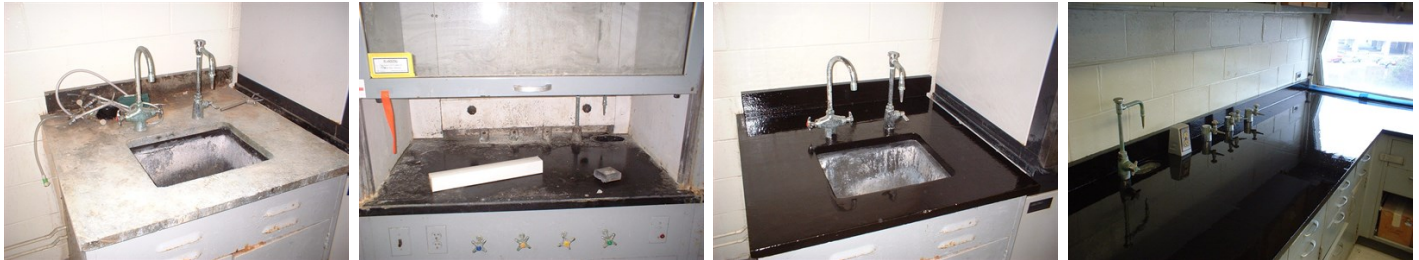
Photograph Descriptions

Severely degraded counter tops needed to be resurfaced with a chemically resistant coating.

* Sink in lab before work , * Fume cupboard before work , * Sink after coating , * Counter top after coating ,

Application carried out in accordance with modified Belzona System leaflet FPA-3. Special care was taken to clean sand the surfaces. Belzona® 5811 applied over-thickness with a trowel to create a self levelling coat.
