# Belzona 2211 gets the trailer back to work.

ID: 9374

Application: *SHM-Solids Handling Machinery*

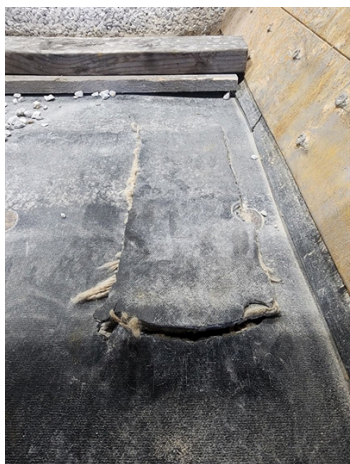
*A tear had formed on the conveyor belt on the gravel hauling trailer.*

Original condition of the belt showing the large area of damage.

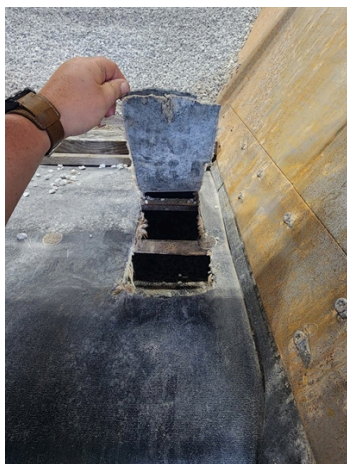
Lifting the torn flap of the conveyor belt to show the extent of the damage.

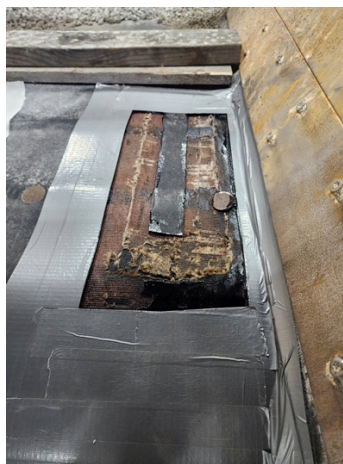
Top layer removed, Belzona 9341 reinforcement sheet pre-cut, border taped off, and Belzona 2911 QD conditioner applied.

All loose rubber was removed, and an area on either side of the tear had the top layer of the belt delaminated to accommodate the Belzona 2211 application and not interfere with the scraper. The exposed surface was cleaned and roughened using a grinder and stiff wire wheel leaving the exposed fabric and rubber rough. The Belzona 2911 QD conditioner was applied and allowed to dry as per the IFU before the Belzona 2211 and Belzona 9341 reinforcement sheet was applied. The duct tape was placed around the edges to achieve a clean application, and was removed as soon as the material was applied.

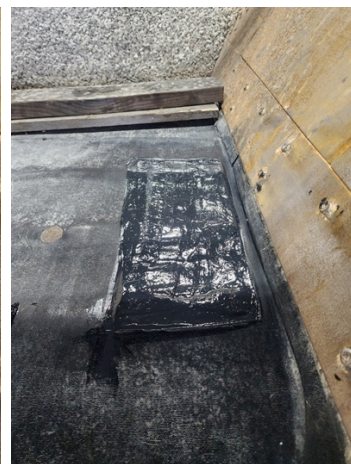
Belzona 2211 application completed.

Only one 550 gm unit of Belzona 2211 was used leaving the customer an extra one for any future applications. The application was completed in roughly two hours, and the trailer will be able to return to service within the following 36 hours. Alternative repair
