# Premiership Football Club Stand still standing!

Customer Location: Nottingham

Application: FPA-Floor Problem Areas

Products: Belzona 2211 (MP Hi-Build Elastomer), Belzona 2911 (Elastomer QD Conditioner), Belzona 4151 (Magma-Quartz Resin), Belzona 4911 (Magma TX Conditioner)

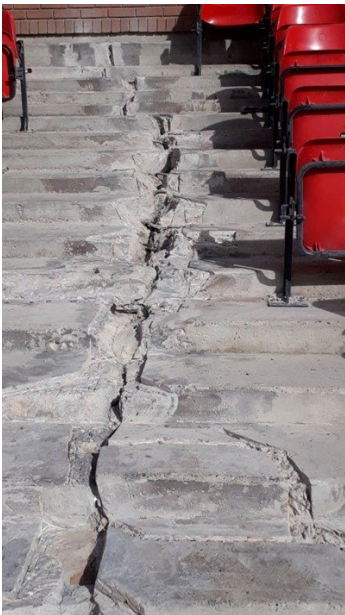
The original issue, with all loose and friable removed, ready for repairs to be made and a 30mm gap to be created

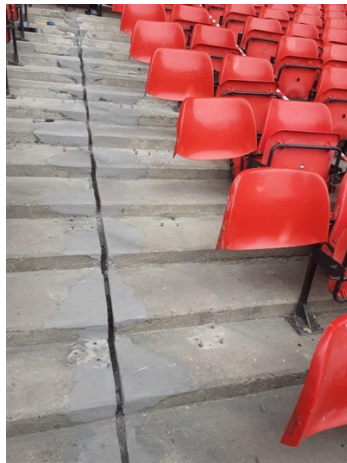
The shoulders have all now been made good and is ready for the bridging tape and the application of the Belzona 2211

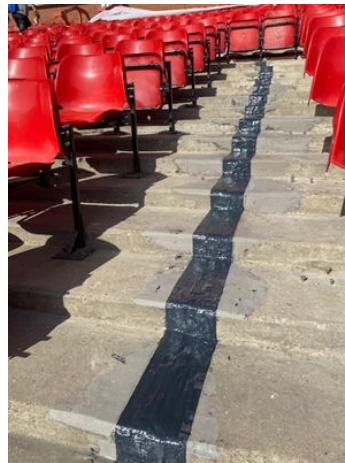
The completed repair and installation of the "accumulator gap"

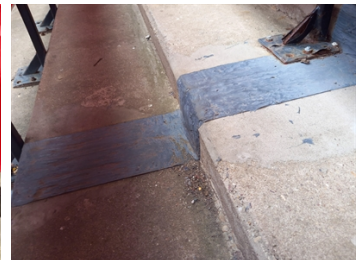
4 years later and the repair is as good now as it was at installation, with no issues created by movement and no further damage to the main football stand
