Sealing of leaks to SF6 Gas Circuit Breaker in large substation

ID: 9380

Industry: Power
Application: GSS-Gaskets, Seals and Shims
Substrate: Other
Products: Belzona 7311

Customer Location: Newark, Nottinghamshire
Application Date: April 2024

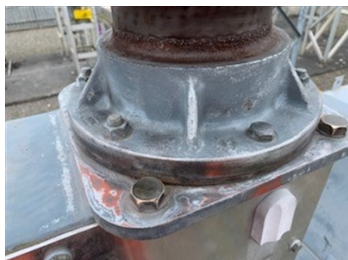
SF6 leaking from joints and bolts

Prepare area with emery paper/ wire brush making surface area as rough as possible.

Abrade the target area as much as possible

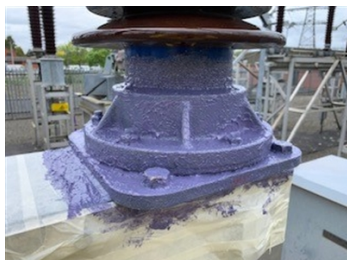
Initial wetting out with a short bristled brush to coat all target areas

Wet out all target areas with mixed Belzona 7311

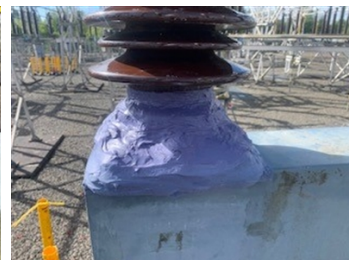
Cover nuts/bolts with belzona filled caps
Wrap with bandage around whole area, overlapping and patching where necessary.

Build up Belzona product, ensuring no air pockets remain. Product given a week to cure before 5 bar restored to the Gas Circuit Breaker

Fill bolt caps and cover all bolts, then apply reinforcing sheet

Build up with Belzona 7311 to encapsulate all possible leaking sites

Allow to cure then introduce gas back to 5 bar working pressure
