One Day Turnaround for Belzona Floor Repair at Iron Ore Mine

Customer Location: Iron ore mine in South Africa

Application: FPA-Floor Problem Areas

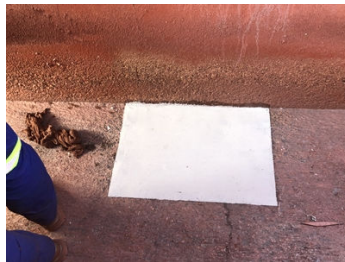
Belzona 4131 applied to damaged area.

Surface preparation was carried out by hand as the substrate was concrete with blue stone in it. Belzona 4911 (Magma TX Conditioner) was first applied to the area, and then Belzona 4131 (Magma-Screed) one metre at a time. Distributor's own application team carried it the application on site.

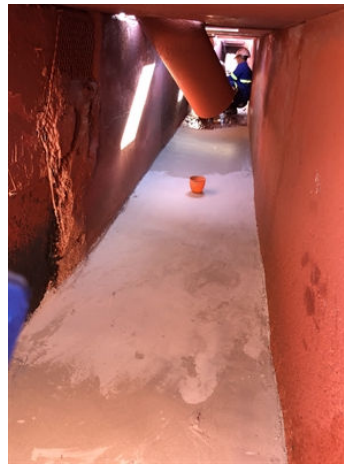
Application in progress

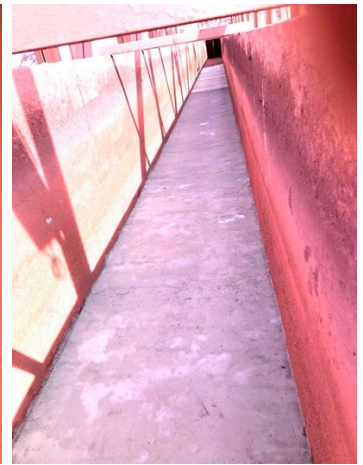
Completed repair with Belzona 4131 in service for 5 years

These initial repairs have been in service for 4-6 years and they show no signs of wear.
