Belzona Nozzle Insert and Corrosion Protection for Demin Vessel

ID: 9383

Customer Location: Petrochemical Facility in South Africa
Application Date: January 2021

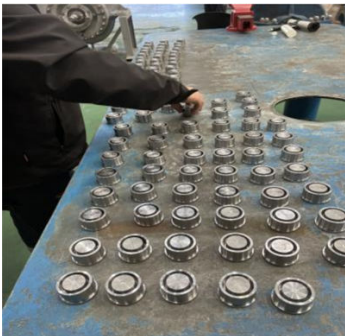
Metal former used to case nozzle inserts

This vessel was approximately 7metres long and 3metres diameter. There were two divider plates, equally spaced inside the vessel. Each divider plate had 420 holes in the plate to accommodate filters. The distributor oversized the holes by 4mm per side and insert and bonded a Belzona nozzle into place to eliminate the corrosion at these points. The Belzona was first cast into a metal former. After curing, the insert was removed and machined to length. 100 formers were manufactured to cast 100 inserts at a time.

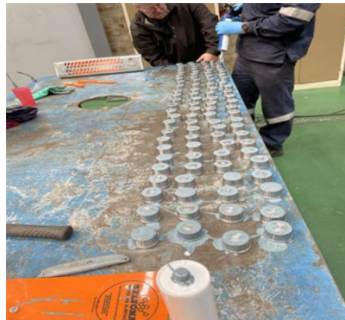
Application in progress of the nozzle inserts

Abrasive blasting to ISO 8501-1 grade Sa 2½ @ minimum 75 microns was implemented before applying inserts and coatings. For the nozzle plates and the 3 splash plates, prefabricated Belzona inserts made from Belzona 1311 and 1391S were recommended for each hole. Depending on hole size, Belzona 1391T or Belzona 1311 were used as an adhesive to bond the insert inside the hole. The

inserts protruded 500 microns past the nozzle plate on both sides. The nozzle plates were then overcoated with Belzona 1391S (2 coats) up to and overlapping the inserts. In addition, due to high flow rate, 1813 (3 mm thickness) and Belzona 1391S/T (2 coats) were applied on top of each splash plate, covering the inserts. The 3 inlet nozzles inside the bores required Belzona 1321.
