Belzona Nozzle Insert and Corrosion Protection for Demin Vessel

ID: 9383

Customer Location: Petrochemical Facility in South Africa

Application: TCC-Tanks and Chemical Containment Areas

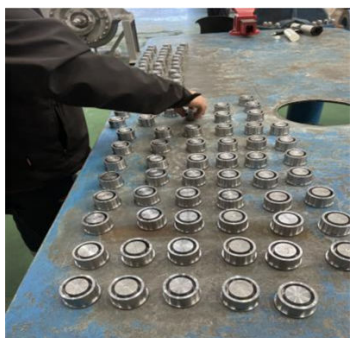
Metal former used to case nozzle inserts

This vessel was approximately 7metres long and 3metres diameter. There were two divider plates, equally spaced inside the vessel. Each divider plate had 420 holes in the plate to accommodate filters. The distributor oversized the holes by 4mm per side and insert and bonded a Belzona nozzle into place to eliminate the corrosion at these points. The Belzona was first cast into a metal former. After curing, the insert was removed and machined to length. 100 formers were manufactured to cast 100 inserts at a time.

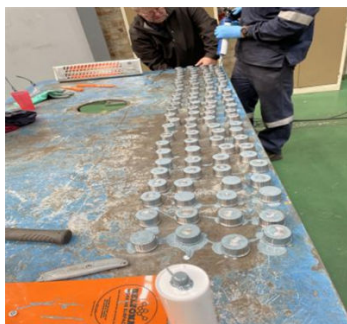
Application in progress of the nozzle inserts

Abrasive blasting to ISO 8501-1 grade Sa 2½ @ minimum 75 microns was implemented before applying inserts and coatings. For the nozzle plates and the 3 splash plates, prefabricated Belzona inserts made from Belzona 1311 and 1391S were recommended for each hole. Depending on hole size, Belzona 1391T or Belzona 1311 were used as an adhesive to bond the insert inside the hole. The

inserts protruded 500 microns past the nozzle plate on both sides. The nozzle plates were then overcoated with Belzona 1391S (2 coats) up to and overlapping the inserts. In addition, due to high flow rate, 1813 (3 mm thickness) and Belzona 1391S/T (2 coats) were applied on top of each splash plate, covering the inserts. The 3 inlet nozzles inside the bores required Belzona 1321.
