# Belzona 1391S Applied to New Cyclonic System

ID: 9385

**Industry:** General Industry  
**Application:** TCC-Tanks and Chemical Containment Areas  
**Substrate:** Carbon steel  
**Products:** Belzona 1391S

**Customer Location:** South Africa  
**Application Date:** August 2023

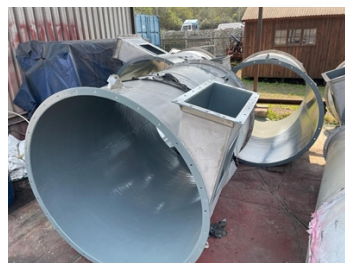
Internals of the cyclones coated

Belzona 1391S was specified due to its ability to withstand chemical attack from the phosphoric acid, as well as the erosive nature of the lime powder/raw materials, and exposure to high temperatures. Belzona 1391S was applied using heated airless equipment as explained in the Information for Use Sheet.
