# Belzona SuperWrap II prepares for the worst

**Industry:** Oil & Gas  
**Application:** VPF-Valves, Pipes and Fittings  
**Substrate:** Carbon steel  
**Products:** Belzona 1111 (Super Metal), Belzona 1982 (SuperWrap II), Belzona SuperWrap II, Belzona 5811 (Immersion Grade), Belzona 7311

**Customer Location:** Spain  
**Application Date:** April 2024

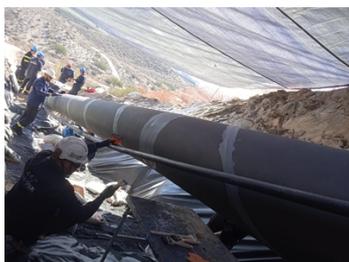
Application start, application of Belzona 1111 to spiral weld area to make a smooth transition

The pipeline is expected to go through wall due to internal corrosion in the 5-7 o'clock position of the pipe at some point in its future, a method was needed to reinforce this area. The pipe was grit blasted to a SA2.5 and a 75 micron minimum finish, to which plates were bonded to the lower section of the pipe with Belzona 7311. This was then wrapped with Belzona SuperWrap II and finished with Belzona 5811

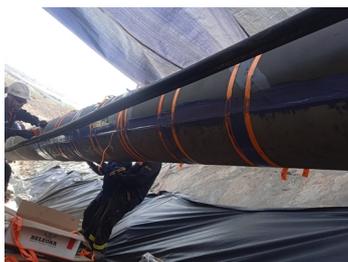
Application of Belzona 7311 plate bonds

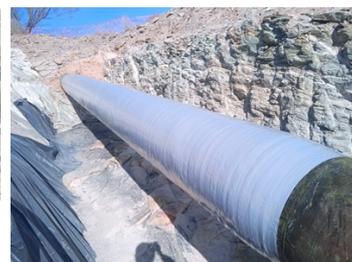
Completed application overcoated with Belzona 5811
