# Belzona repairs waste water clarifier base

Industry: Water / Wastewater

Customer Location: Glasgow, Scotland

Application: FPA-Floor Problem Areas

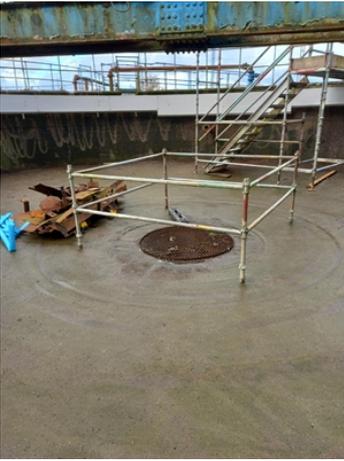
A waste water concrete clarifier had a worn uneven surface after years of harsh service. This meant the clarifier could not operate properly & waste sludge was collecting on the bottom of the tank.

Worn surface

The area was washed & abraded to get back to sound concrete. Any deep areas were filled with Belzona 4131 before the larger screeding application. 6mm of Belzona 4131 was then applied over the full base of the clarifier. Metal screed rails were used to control the thickness & maintain a constant level.

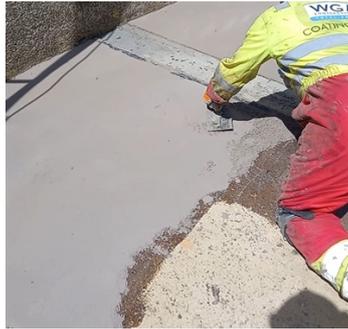
Application in progress

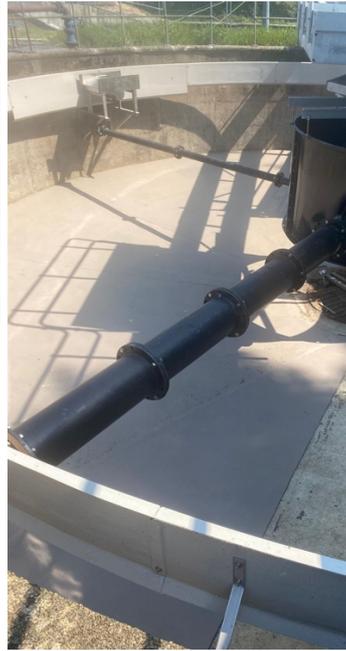
Completed section

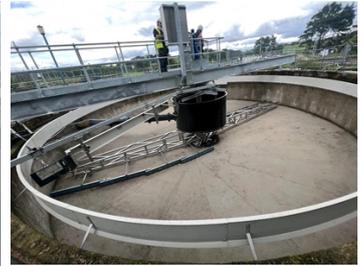
Finished application

By using this solution the clarifier was back in action with minimal disruption to the surrounding plant. An additional clarifier application on this site is due to commence 2024.
