Belzona repairs waste water clarifier base

ID: 9400

Industry: Water / Wastewater

Customer Location: Glasgow, Scotland

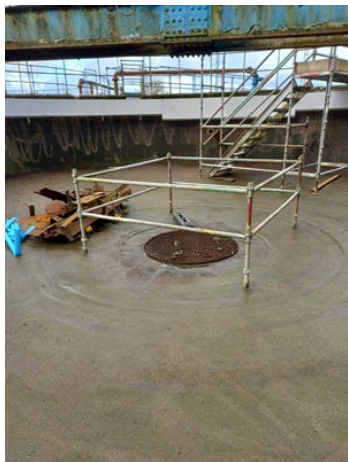
A waste water concrete clarifier had a worn uneven surface after years of harsh service. This meant the clarifier could not operate properly & waste sludge was collecting on the bottom of the tank.

Worn surface

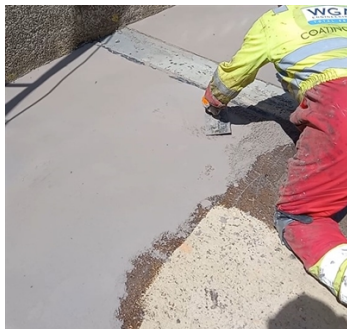
Application in progress

The area was washed & abraded to get back to sound concrete. Any deep areas were filled with Belzona 4131 before the larger screeding application. 6mm of Belzona 4131 was then applied over the full base of the clarifier. Metal screed rails were used to control the thickness & maintain a constant level.

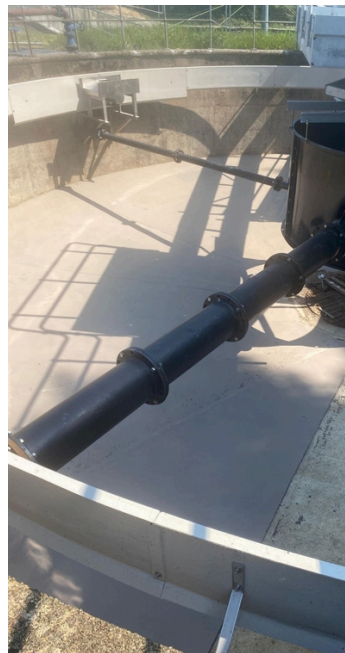
Completed section

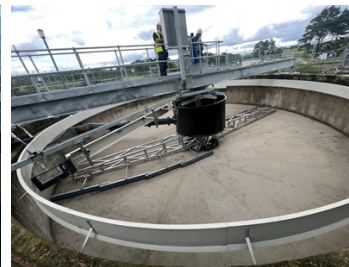
Finished application

By using this solution the clarifier was back in action with minimal disruption to the surrounding plant. An additional clarifier application on this site is due to commence 2024.
