# Belzona repairs waste water clarifier base

ID: 9400

Application: FPA-Floor Problem Areas

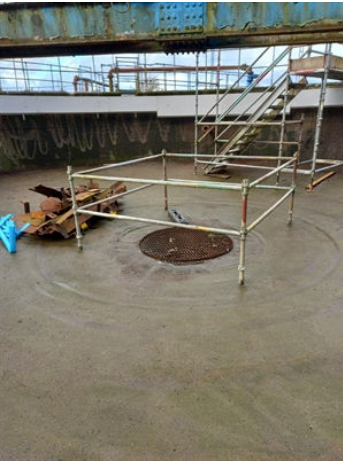
A waste water concrete clarifier had a worn uneven surface after years of harsh service. This meant the clarifier could not operate properly & waste sludge was collecting on the bottom of the tank.

Worn surface

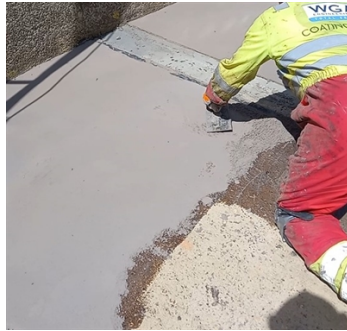
Application in progress

The area was washed & abraded to get back to sound concrete. Any deep areas were filled with Belzona 4131 before the larger screeding application. 6mm of Belzona 4131 was then applied over the full base of the clarifier. Metal screed rails were used to control the thickness & maintain a constant level.

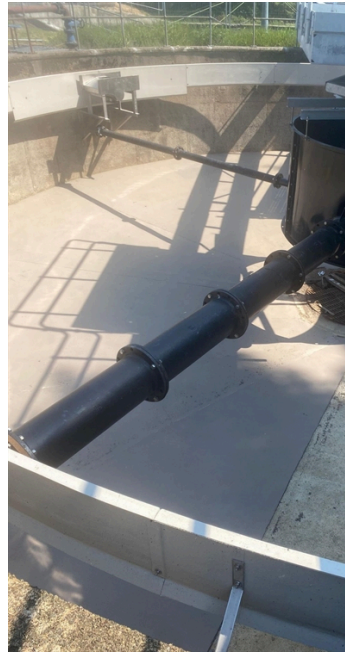
Completed section

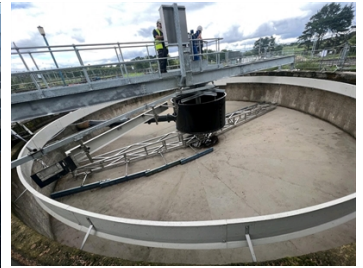
Finished application

By using this solution the clarifier was back in action with minimal disruption to the surrounding plant. An additional clarifier application on this site is due to commence 2024.
