Belzona saves the sump

ID: 9405

Industry: Chemical & Petrochemical
Application: TCC-Tanks and Chemical Containment Areas

Substrate: Concrete

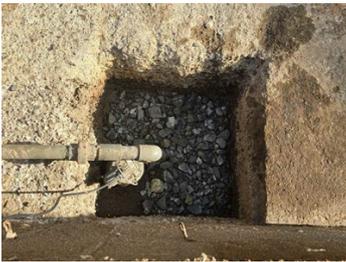
Chemical erosion had damaged this sump to the extent that there was no concrete left on the bottom of the sump, and the sides had major damage.

The sump in its original condition.

The concrete in this sump was heavily damaged by chemical erosion over several years. Upon cleaning it out it was discovered that the bottom of the sump was completely missing with only gravel and dirt remaining.

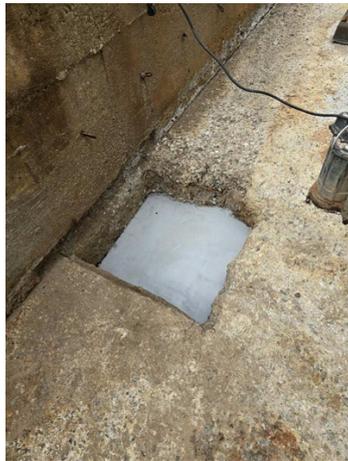
The sump after applying 3 buckets of 4111 to the bottom.

We packed in about 6" of rock and gravel into the bottom of the sump and then applied 3 buckets of 4111 to the base. Once that was firm, we used 4911 to condition the walls and edges of the 4111 floor and inserted a plywood former box wrapped in plastic. We then mixed a slurry of 4111 by mixing a full batch according to the IFU and then adding one additional unit of 4151 to create a pourable mix that would fill around the former. Once cured, the former was easily removed leaving a perfect rebuilt sump. The sump and containment was then coated with Belzona 5811 to provide protection from the chemicals inside the containment.

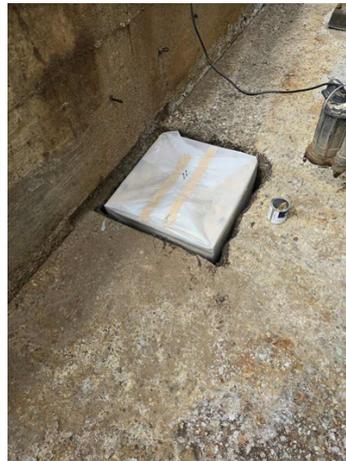
The sump with the plastic wrapped plywood former installed.

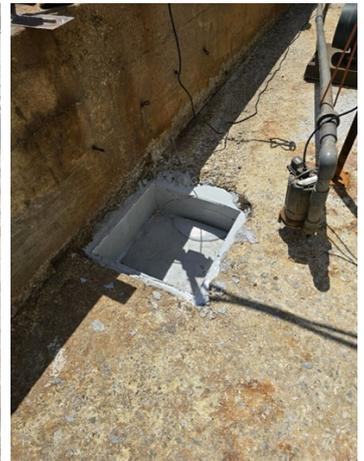
The sump after pouring a slurry mix of 4111 around the former. Application complete.
