# Concrete Floor Repairs

ID: 9406

Industry:	General Industry	Customer Location:	Southwestern Ontario
Application:	FPA-Floor Problem Areas	Application Date:	April 2023
Substrate:	Concrete		
Products:	Belzona 4111 (Magma-Quartz), Belzona 4911 (Magma TX Conditioner), Belzona 9111 (Cleaner Degreaser)

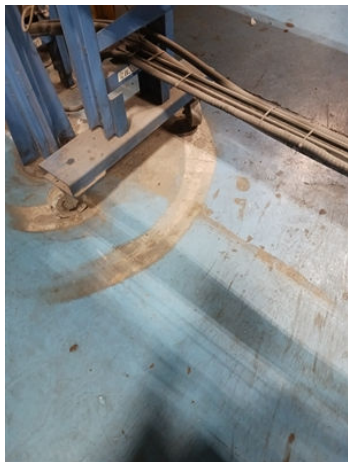
The customer was experiencing that their steel wheel conveyor system due to heavy loads were wearing grooves into the concrete floor.

Floor area showing where the grooves have been repaired on this conveyor.

Concrete floor at the moving conveyor production area was in need of repairs and the customer was in need of a quick fix.

Application was carried out using the Belzona System Leaflet FPA-1

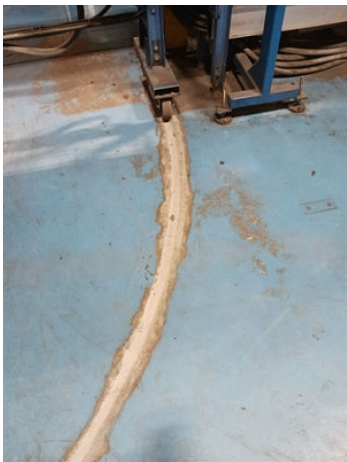
Floor area showing where the grooves have been repaired on this conveyor.

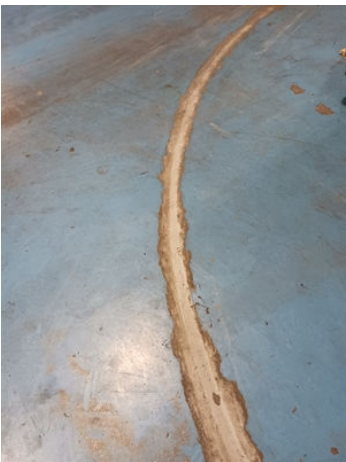
Floor area showing where the grooves have been repaired on this conveyor.
