Concrete Floor Repairs

ID: 9406

Industry: *General Industry* **Customer Location:** *Southwestern Ontario*
Application: *FPA-Floor Problem Areas* **Application Date:** *April 2023*
Substrate: *Concrete*
Products: *Belzona 4111 (Magma-Quartz), Belzona 4911 (Magma TX Conditioner), Belzona 9111 (Cleaner Degreaser)*

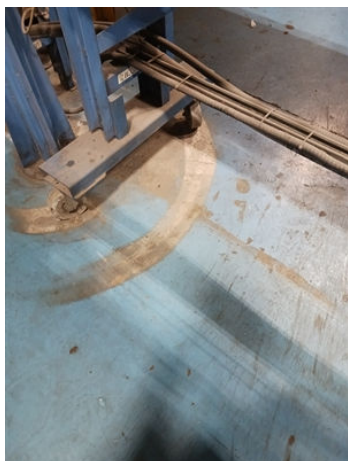
Floor area showing where the grooves have been repaired on this conveyor.

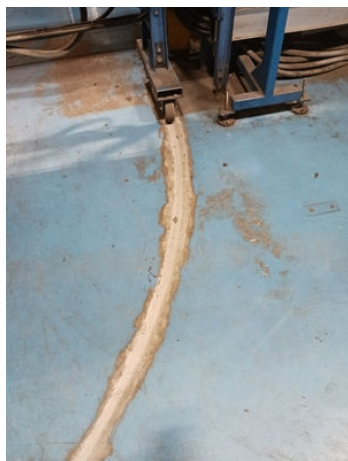
Floor area showing where the grooves have been repaired on this conveyor.

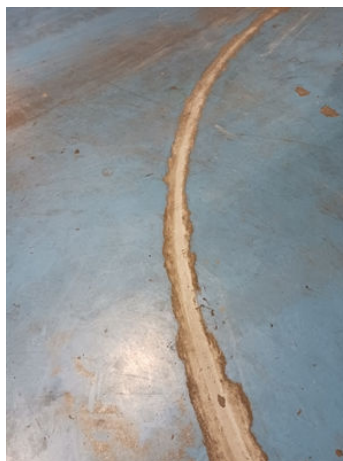
Floor area showing where the grooves have been repaired on this conveyor.
