Belzona blocks the leaks in secondary containment

ID: 9407

Application: FPA-Floor Problem Areas

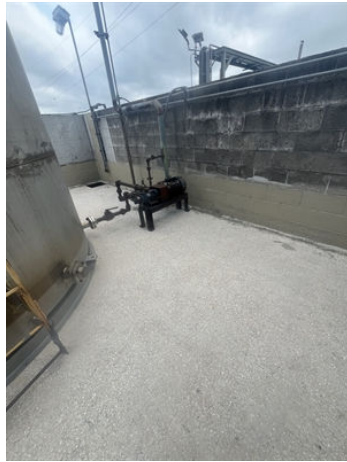
Area after grit blasting

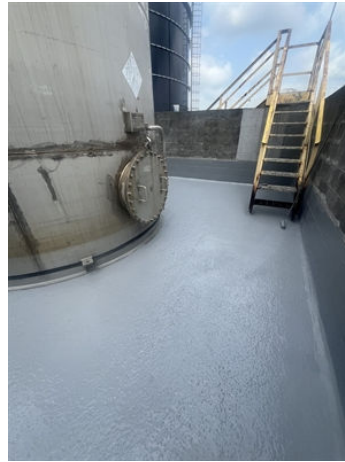
Floor after the second coat

Abrasive profile/Eco-Blast all areas that were to be coated. Rebuilt damaged area with Belzona 4124 and coated two coats of Belzona 5811. Block wall with cracks were filled with Belzona 4111, coated with Belzona 5815 with 9341 reinforced system,

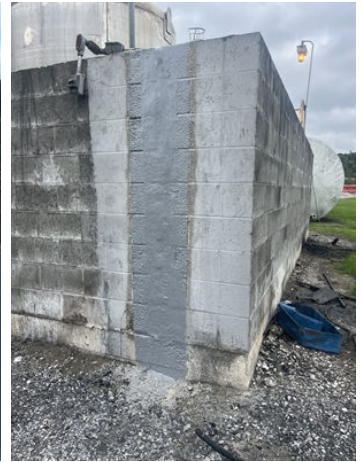
The secondary containment had formed some cracks over time in the block wall and where the concrete meets the wall.

The crack in the outside of wall that was repaired with Belzona and coated
