BELZONA TANK PLATE BONDING

Industry: Oil & Gas
Application: TCC-Tanks and Chemical Containment Areas
Substrate: Mild Steel
Products: * Belzona® 1121 (Super XL-Metal) ,
* Belzona® 5811 (Immersion Grade) ,

Customer Location: Oil Distributor, Merseyside, England
Application Date: October 2006

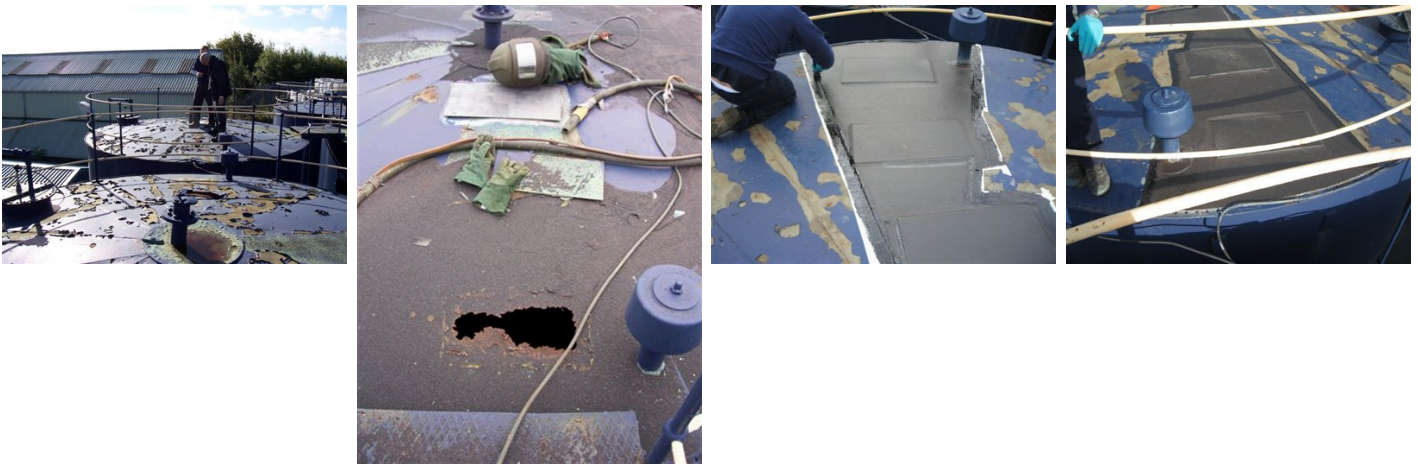
Photograph Descriptions

Existing coating had delaminated from tank roofs exposing steelwork underneath. This in turn corroded resulting in holed tank roofs.

- * General condition of tank roofs ,
- * Blasting the substrate ,
- * Plates in position & Belzona® 5811 being applied ,
- * Completed application ,

Application was carried out in accordance with Belzona System Leaflets TCC-1 & TCC-5. Belzona® 1121 used to bond plates. Repair then overcoated with Belzona® 5811 to provide corrosion protection.

Customer chose cold repair over welding as tanks contained parrafin and diesel.
