BELZONA TANK PLATE BONDING

ID: 941

Customer Location: Oil Distributor, Merseyside, England
Application Date: October 2006

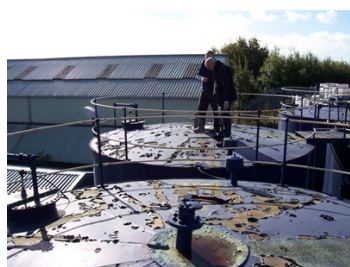
Existing coating had delaminated from tank roofs exposing steelwork underneath. This in turn corroded resulting in holed tank roofs.

- * General condition of tank roofs ,
- * Blasting the substrate ,
- * Plates in position & Belzona® 5811 being applied ,
- * Completed application ,
