Stainless Steel Propeller Repair and Protection

ID: 9411

Industry: Marine
Application: SOS-Ships and Offshore Structures

Substrate: Stainless-steel
Products: Belzona 1311 (Ceramic R-Metal), Belzona 1341 (Supermetalglide), Belzona 2141 (ACR-Fluid Elastomer), Belzona 2941 (Elastomer SP-Conditioner)

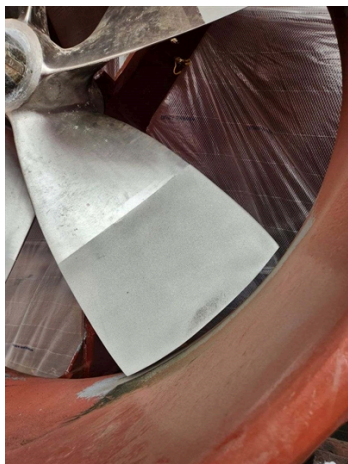
Problem
Areas of cavitation damage

Vessel owner was in a rush to get the vessel back in service. Removing the propellers for outside repairs would not fit the timeframe allowed. Based on previous case studies, the owner and shipyard agreed on the application.

Replacing the propellers was not an option based on availability. Repair by welding required removing the parts and sending them to an outside shop.

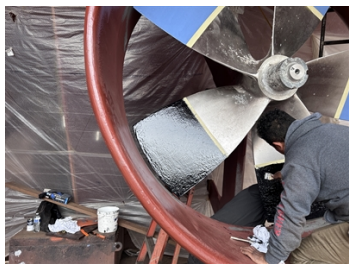
1st coat applied was Belzona 1341

Tips of blades were grit blasted to a minimum of 3mils. Cavitation pockets were filled with Belzona 1311. For protection, Belzona 1341 was applied in a 10mil coat. Belzona 2941 surface conditioner was then applied followed by a 30mil coat of Belzona 2141.

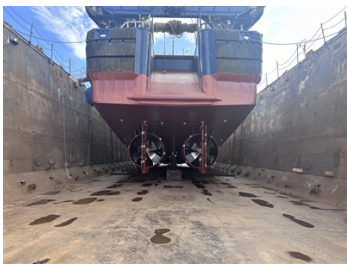
2nd coat applied was Belzona 2141

Vessel ready to return to service
