Stainless Steel Propeller Repair and Protection

ID: 9411

Industry: *Marine*
Application: *SOS-Ships and Offshore Structures*

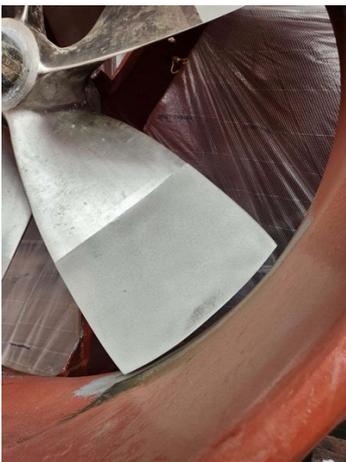
Problem

Areas of cavitation damage

Vessel owner was in a rush to get the vessel back in service. Removing the propellers for outside repairs would not fit the timeframe allowed. Based on previous case studies, the owner and shipyard agreed on the application.

Replacing the propellers was not an option based on availability. Repair by welding required removing the parts and sending them to an outside shop.

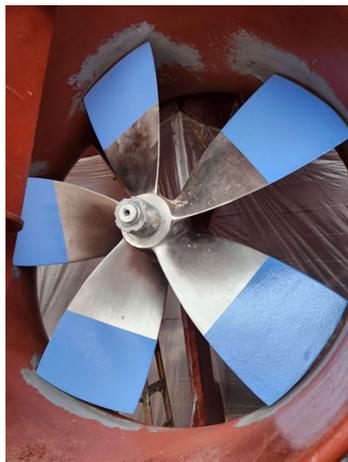
Tips of blades grit blasted

Tips of blades were grit blasted to a minimum of 3mils. Cavitation pockets were filled with Belzona 1311. For protection, Belzona 1341 was applied in a 10mil coat. Belzona 2941 surface conditioner was then applied followed by a 30mil coat of Belzona 2141.

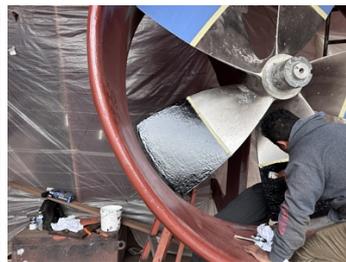
1st coat applied was Belzona 1341

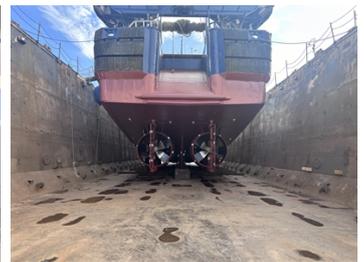
2nd coat applied was Belzona 2141

Vessel ready to return to service
