Sulfuric Acid Flange Repairs with Belzona 4301

ID: 9415

Industry: Oil & Gas
Application: VPF-Valves, Pipes and Fittings
Substrate: Carbon steel
Products: Belzona 4301 (Magma CR1 Hi-Build)

Customer Location: Addis, Louisiana
Application Date: April 2024

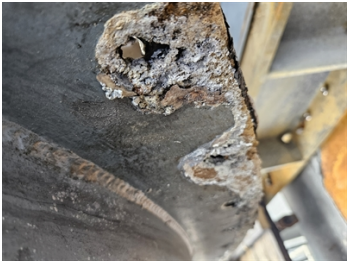
Damaged Flange from sulfuric acid.

Flange with Sulfuric Acid Damage

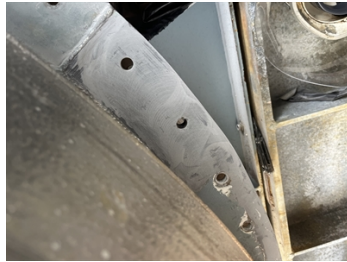
Flange After Repair with Belzona 4301

-prepared the substrate on the damaged area as listed and points surrounding the damaged area.

-Applied Belzona 4301 system to the area of repair as listed.

-Allowed full cure of product prior to applying any chemicals, this took 4-Days at 86 degrees F.

Profile of 3 mils

Blasted clean to SSPC SP 10

Utilized stiff Bristle brush to apply fully conditioned Belzona 4301
