Sulfuric Acid Flange Repairs with Belzona 4301

Industry: Oil & Gas
Application: VPF-Valves, Pipes and Fittings
Substrate: Carbon steel
Products: Belzona 4301 (Magma CR1 Hi-Build)

Customer Location: Addis, Louisiana
Application Date: April 2024

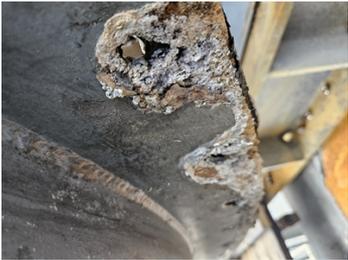
Damaged Flange from sulfuric acid.

Flange with Sulfuric Acid Damage

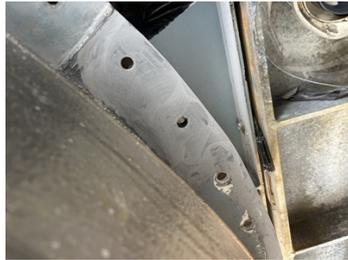
Flange After Repair with Belzona 4301

-prepared the substrate on the damaged area as listed and points surrounding the damaged area.

-Applied Belzona 4301 system to the area of repair as listed.

-Allowed full cure of product prior to applying any chemicals, this took 4-Days at 86 degrees F.

Profile of 3 mils

Blasted clean to SSPC SP 10

Utilized stiff Bristle brush to apply fully conditioned Belzona 4301
